# Manhole Inspection Summary

Manhole # S19CC2010MH

Insp Date: **11/20/06 3:24 PM**

**Location** Address: **5622 MATTFELDT AVE**

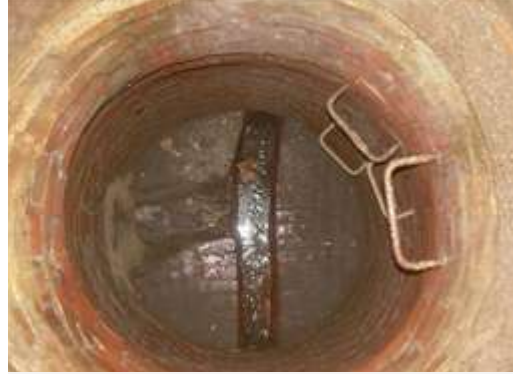
Top View

Evidence of surcharge - Bench debris.  
Channel debris.

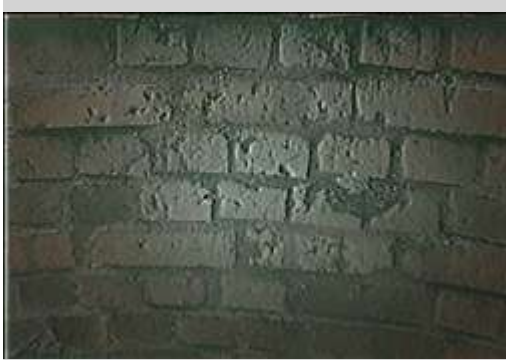
Defect

Barrel infiltration.

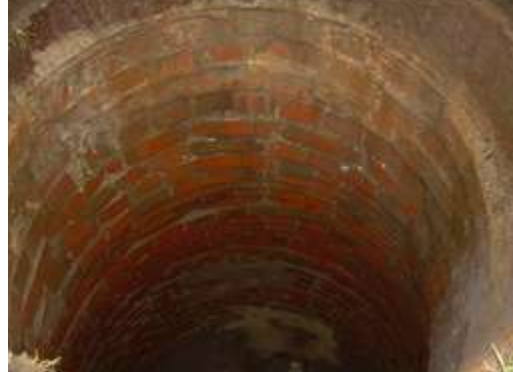
Defect

Frame leaks. Adjustment deterioration  
and infiltration. Barrel infiltration.

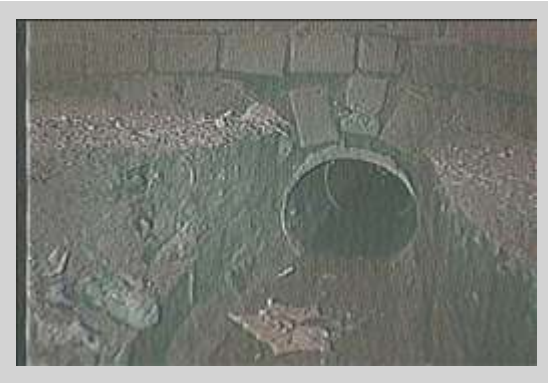
### 8 in. Circular Gravity Sewer Pipe Out @ 12 O'Clock

Barrel infiltration.

Infiltration: **Evidence** Pipe Seal Cond: **Unknown**

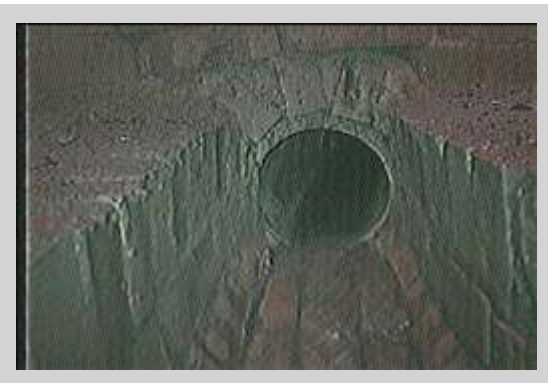
### 8 in. Circular Gravity Sewer Pipe In @ 6 O'Clock

Infiltration: **Evidence** Pipe Seal Cond: **Unknown**

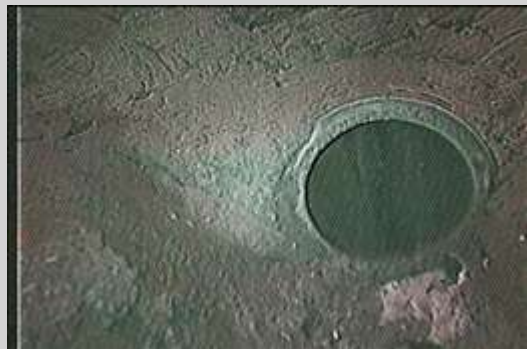
Pipe In @ 9 O'Clock

Infiltration: **Evidence**
